10 Emergency Power

Executive Summary

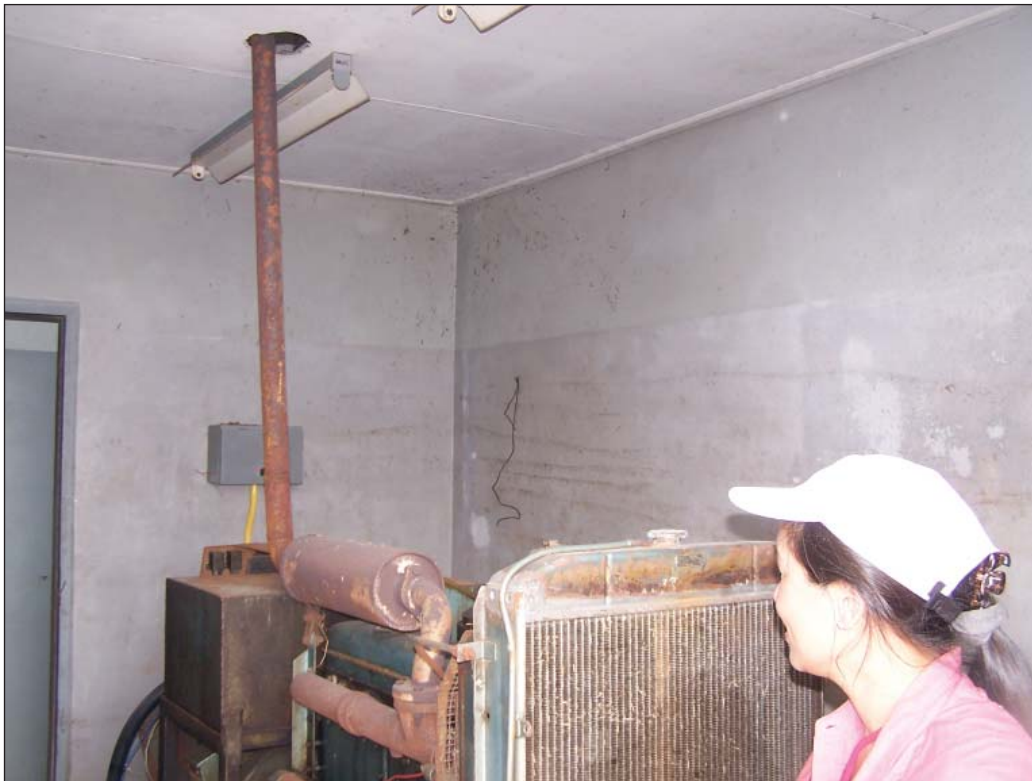
A good example is the emergency generator at the water treatment plant at the Royal Thai Navy base in Baan Nam Kem. This location nearly 2 km inland had a run up of over 2 m. The generator and all other ground level electrical equipment was ruined (Figure 10.1). At the time of our inspection, there had been no attempt to repair the generator.

Fig. 10.1 Emergency generator at the water treatment plant. Note the high water marks on the walls and the debris in the radiator grill.
