# HISTORY LESSON

## Preserved For the Future: Cape Hatteras Lighthouse

The 4,830 ton lighthouse was moved 2,900 ft southwest of its original location to preserve it from the encroaching sea.

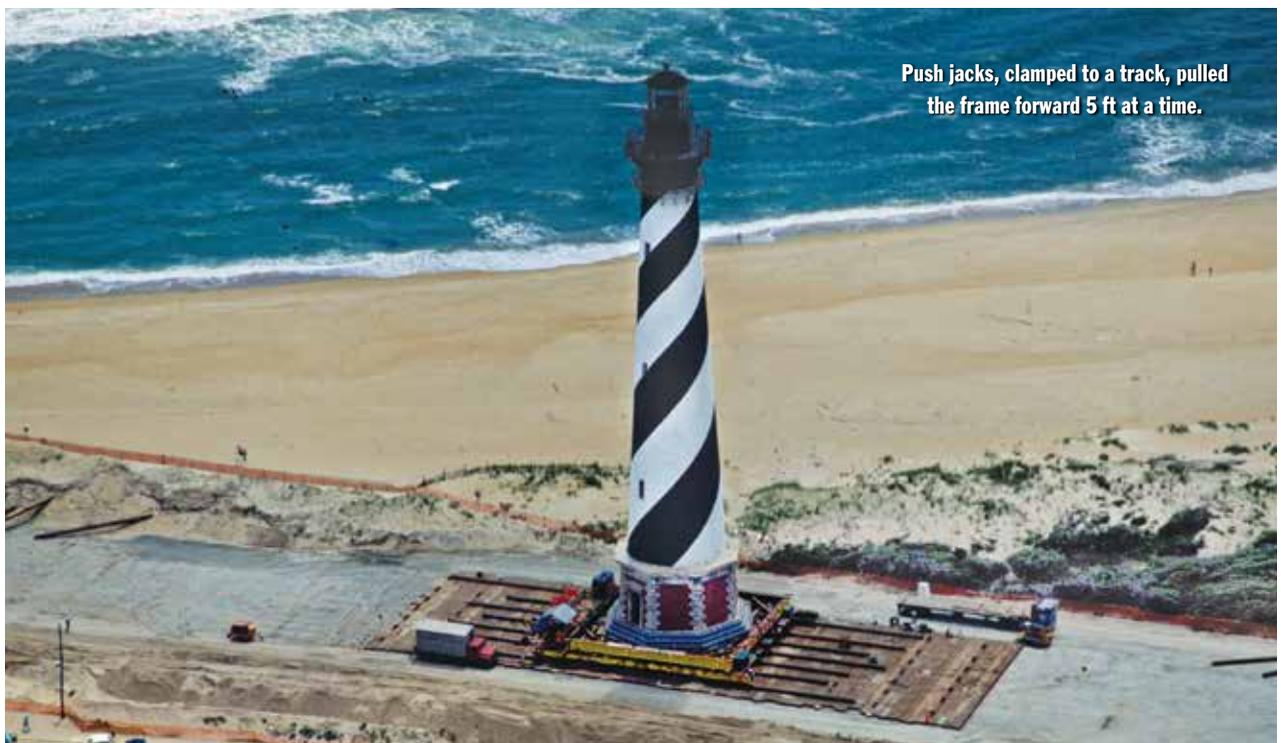
Push jacks, clamped to a track, pulled the frame forward 5 ft at a time.

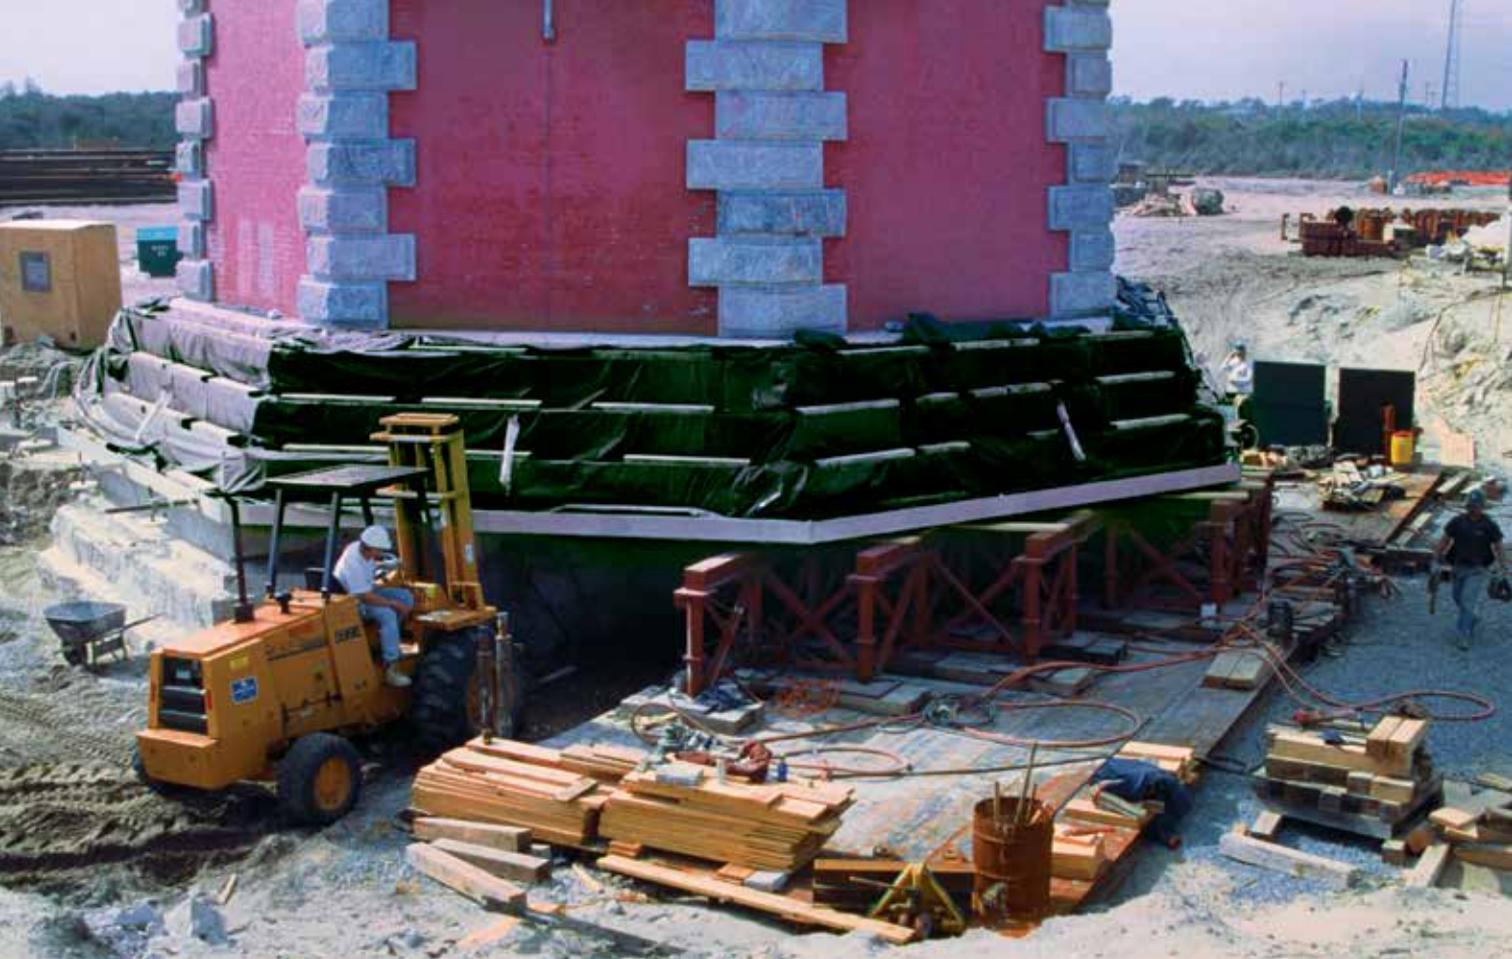
**Temporary shoring beams replaced the lighthouse’s foundation as it was prepared for its move.**

Temporary shoring beams replaced the foundation, and then “a steel beam

mat was inserted over the timber mat with temporary posts on top,” the NPS site states. “As cross beams and main beams were set, the temporary shoring parts and beams were removed.”
